Super Salvage, Inc.
Industrial Stormwater Inspection Report

Appendix B

Photograph Log and Photographs

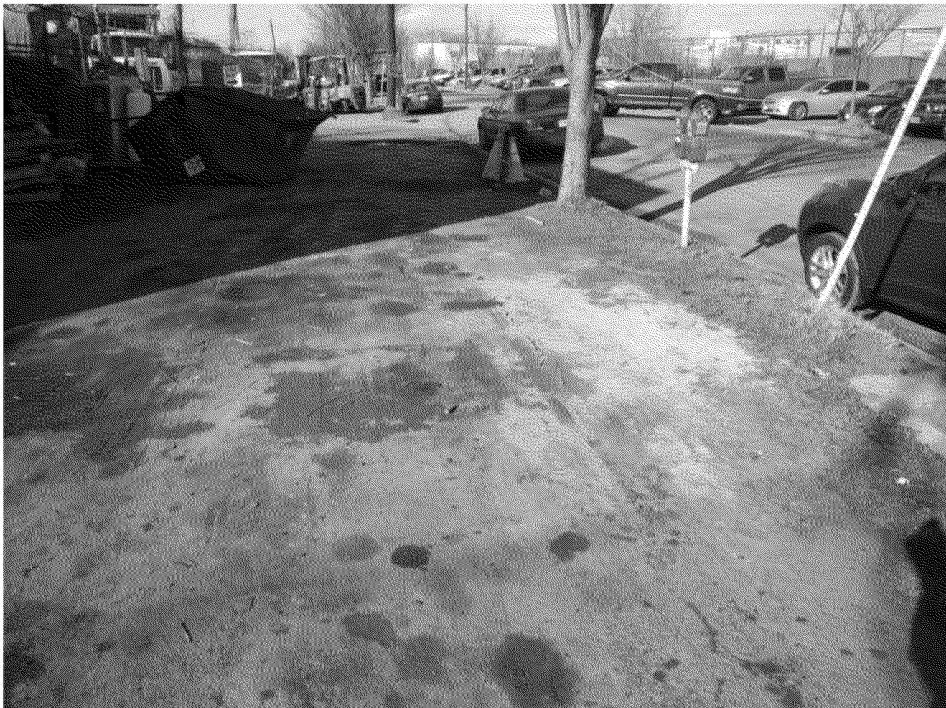
Photograph 84. Stains on the sidewalk adjacent to the site near the corner of First Street SW and S Street SW.
